**ON-SITE AIR BAG INVESTIGATION**

**CASE NO. - 94-11**  
**FLEET - RENTAL VEHICLE**  
**LOCATION - [REDACTED] INDIANA**  
**ACCIDENT DATE - [REDACTED] 1994**

**Contract Number: DTNH22-94-D-17058**

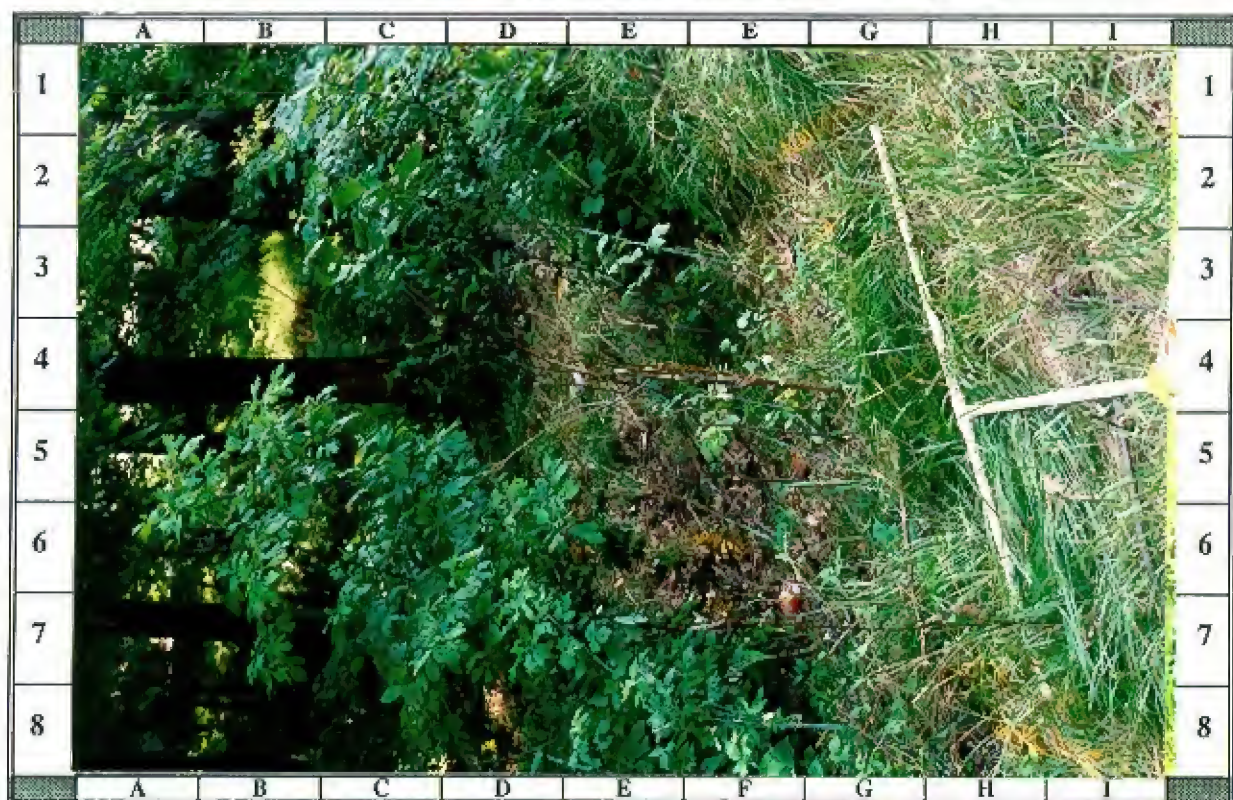
# 22 -- 1994 Oldsmobile Cutlass Ciera's southward travel path down south roadside ~ 10 meters from impact with large (~37 cm) tree

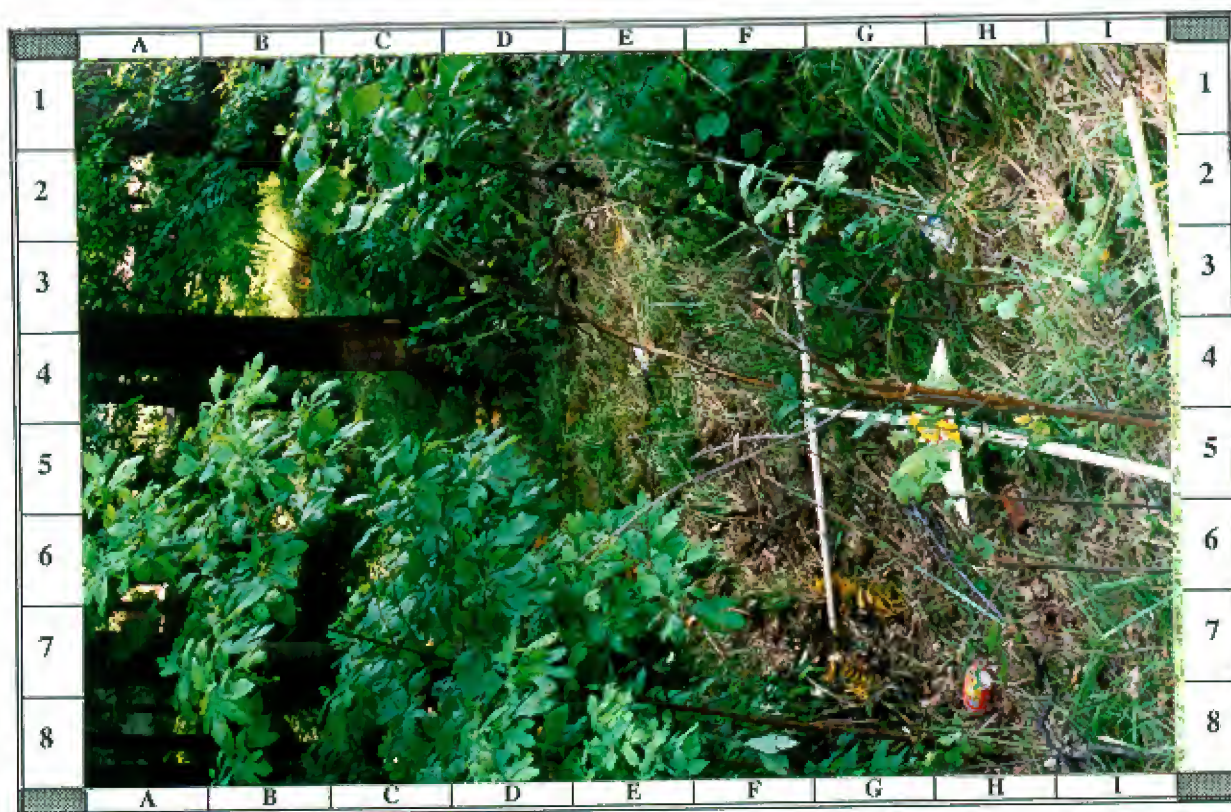
# 23 -- 1994 Oldsmobile's southward travel path down south roadside ~ 6 meters from large tree impact; NOTE: LF tire mark in cell G7

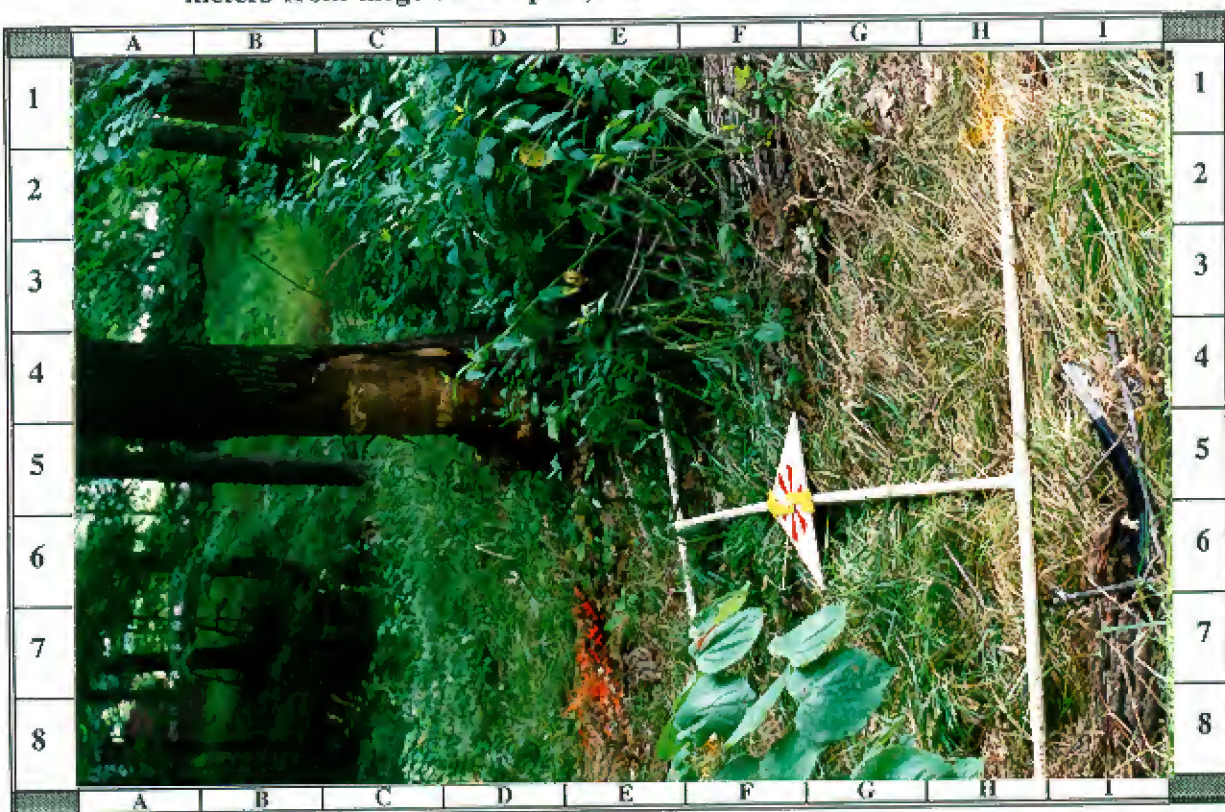
# 24 -- 1994 Oldsmobile Cutlass Ciera's southward travel path down south roadside at impact with large (~37 cm) tree

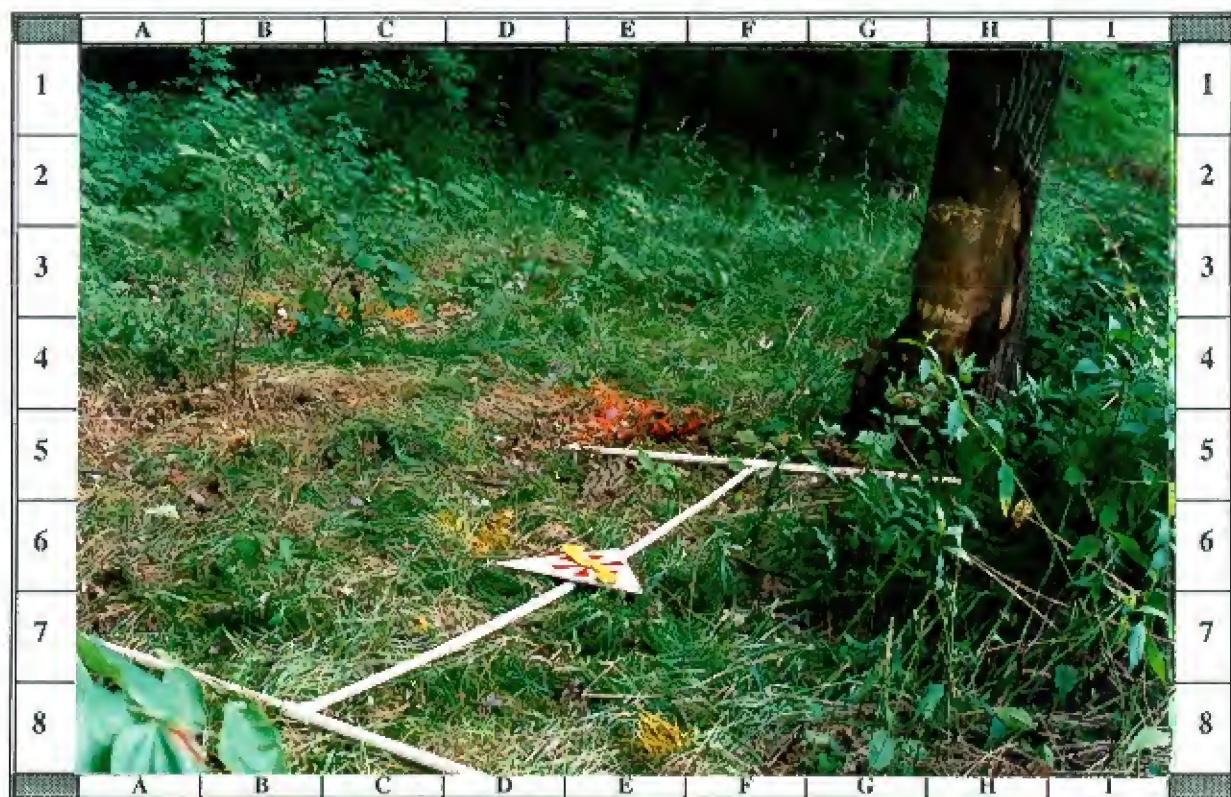
# 25 -- 1994 Oldsmobile Cutlass Ciera S's position at maximum engagement with large (~37 cm) tree and start of clockwise rotation

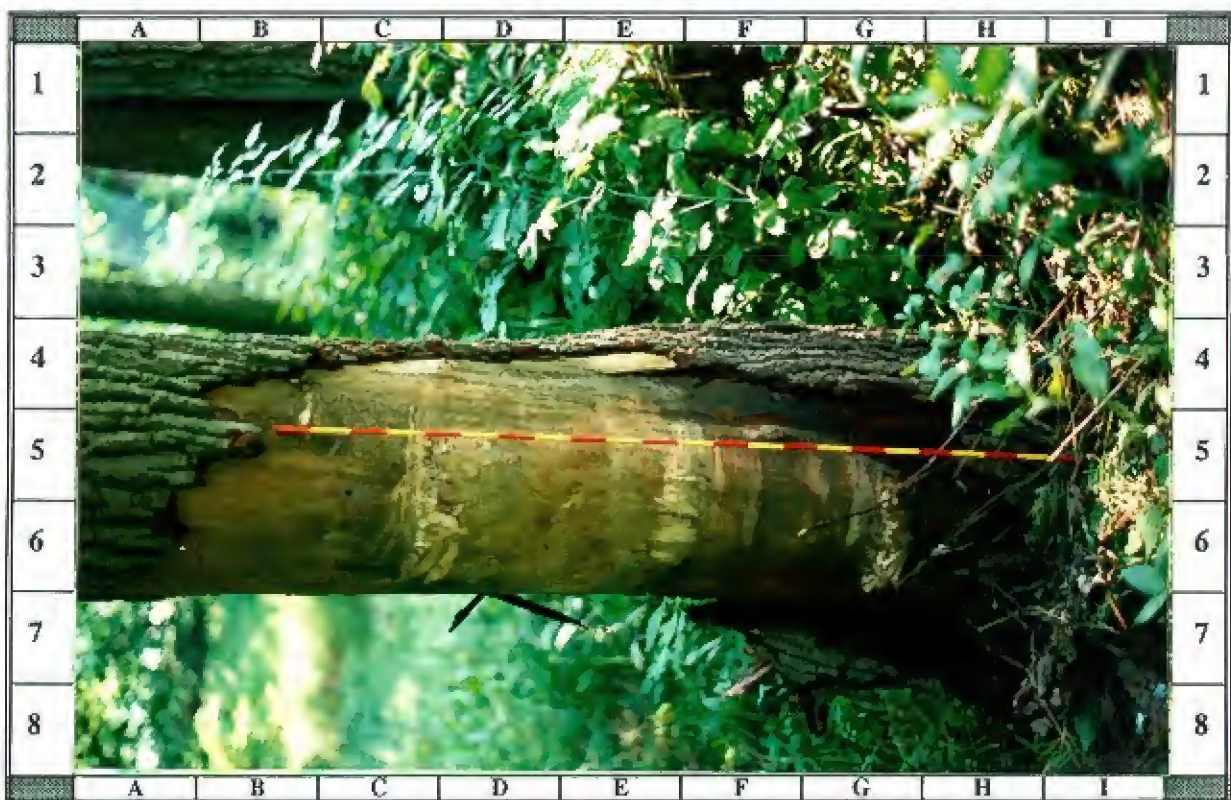
# 26 -- Close-up of large (~37 cm) tree impacted by 1994 Oldsmobile Cutless Ciera S; NOTE: distinct transverse tree damage

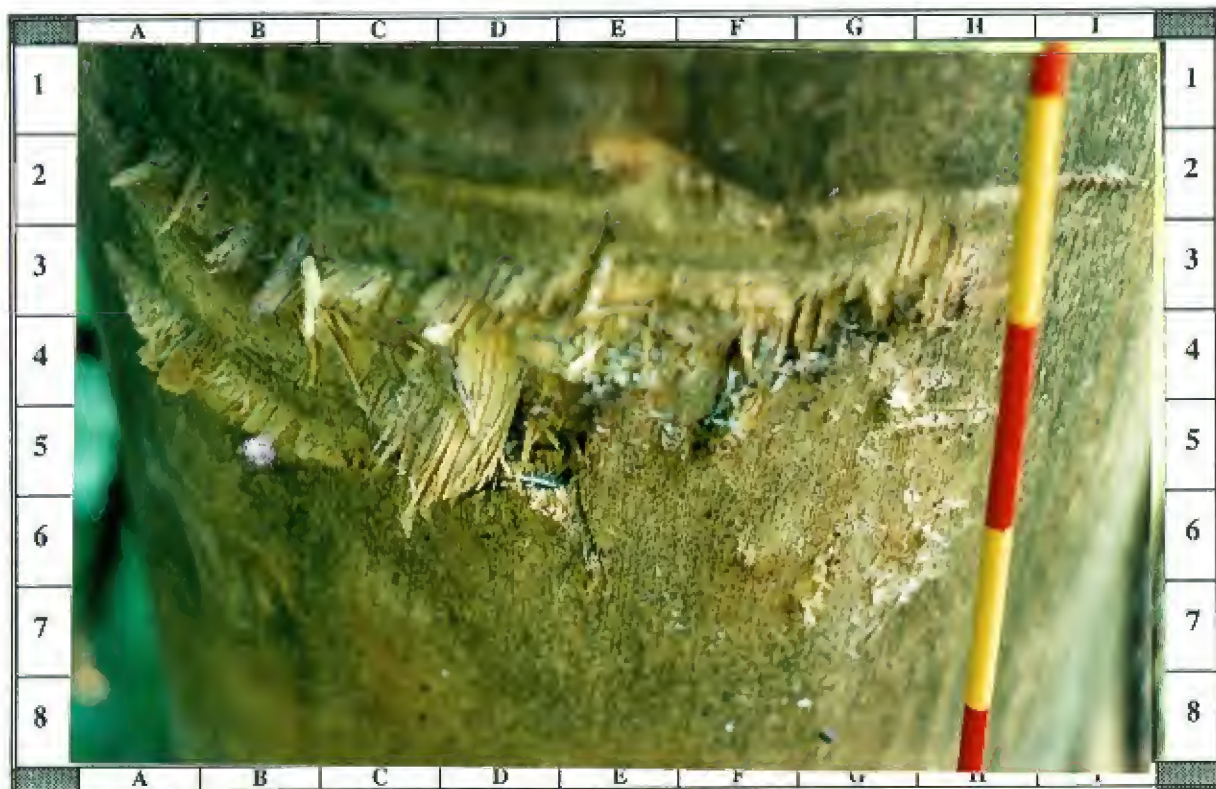
# 27 -- Closer-up of topmost transverse tree damage showing plastic and metal embedded in tree from impact with 1994 Oldsmobile Cutlass

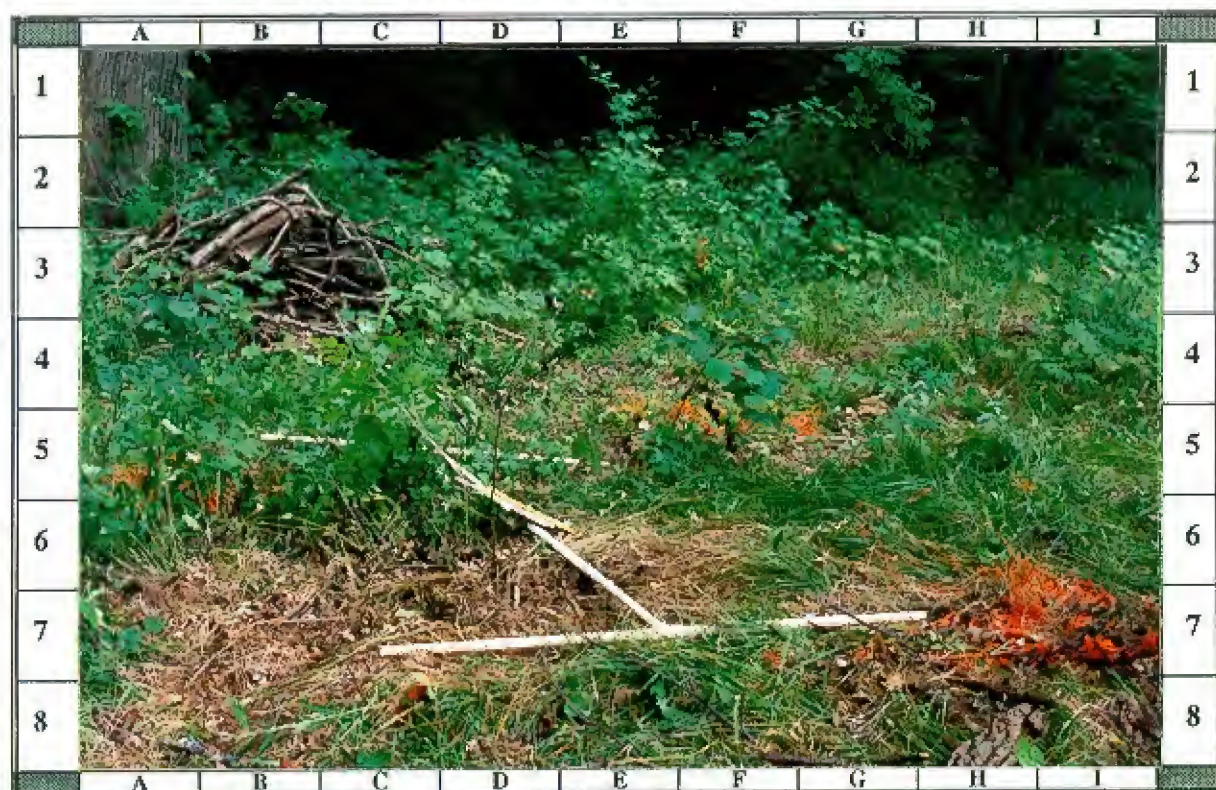
# 28 -- Final rest position of 1994 Oldsmobile Cutlass Ciera S heading west-northwest; NOTE: orange paint marks are from police

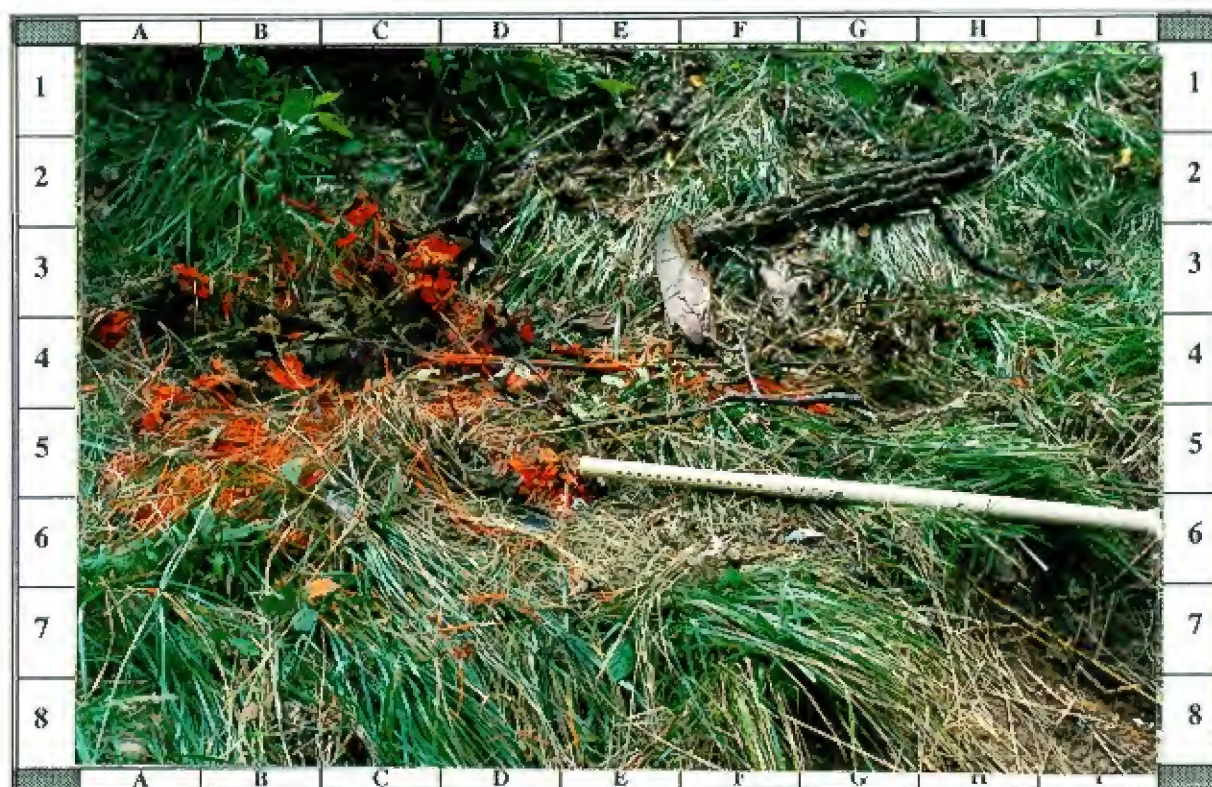
# 29 -- Final rest position of '94 Oldsmobile Cutlass Ciera's left front tire looking northward; NOTE: orange paint mark is from police

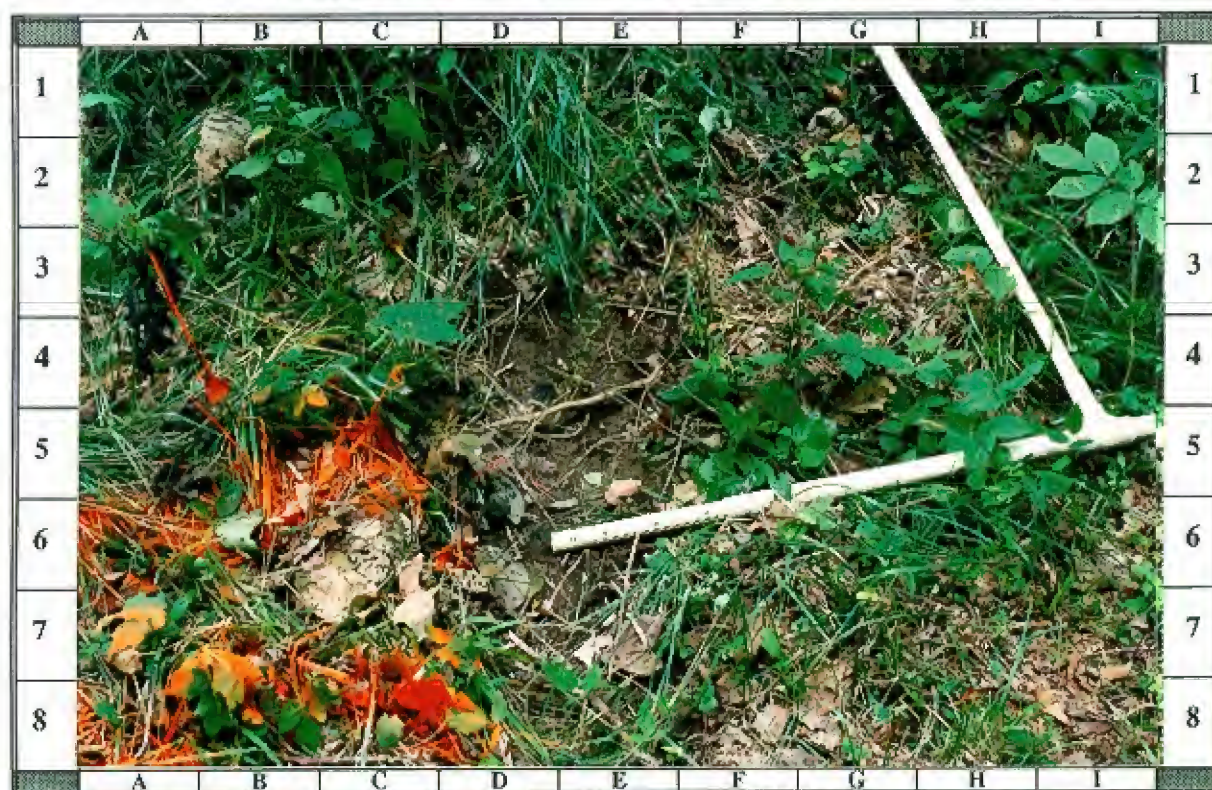
# 30 -- Final rest position of '94 Oldsmobile Cutlass Ciera's left rear tire looking northward; NOTE: orange paint mark is from police

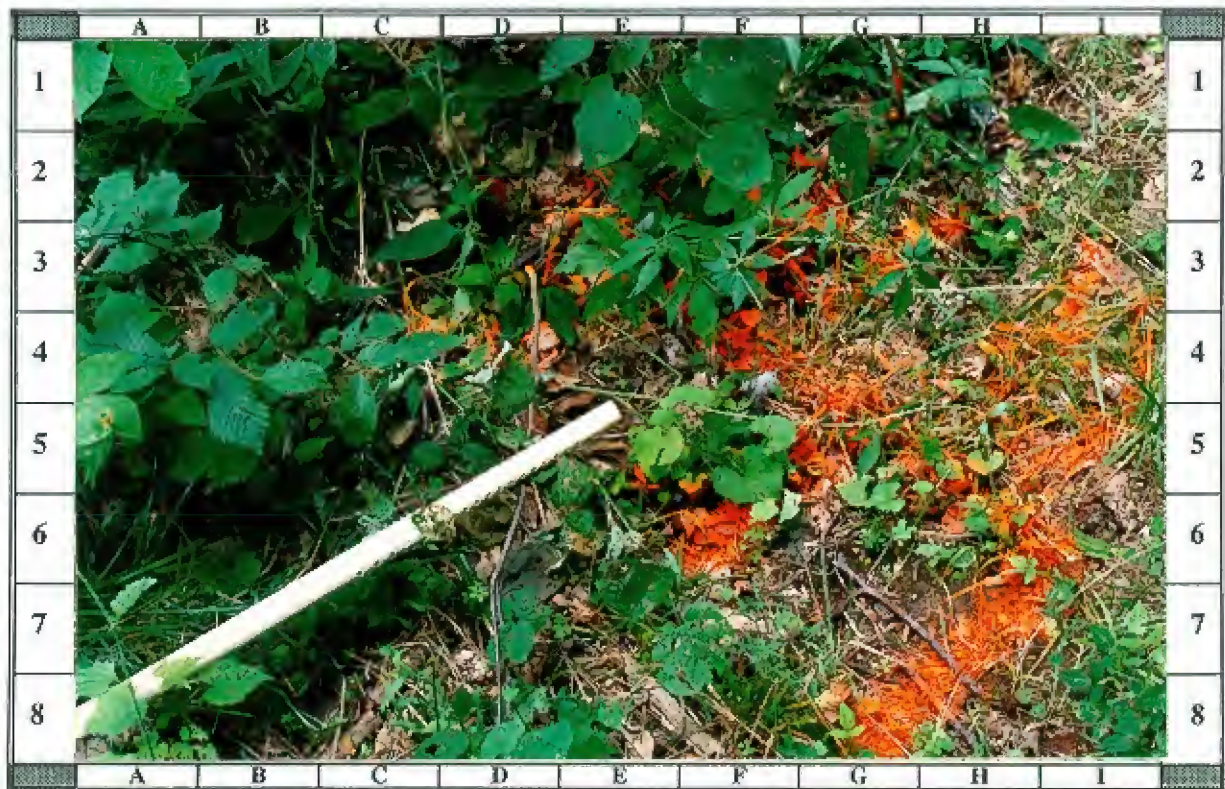
# 31 -- Final rest position of '94 Oldsmobile Cutlass Ciera's right rear tire looking northward; NOTE: orange paint mark is from police

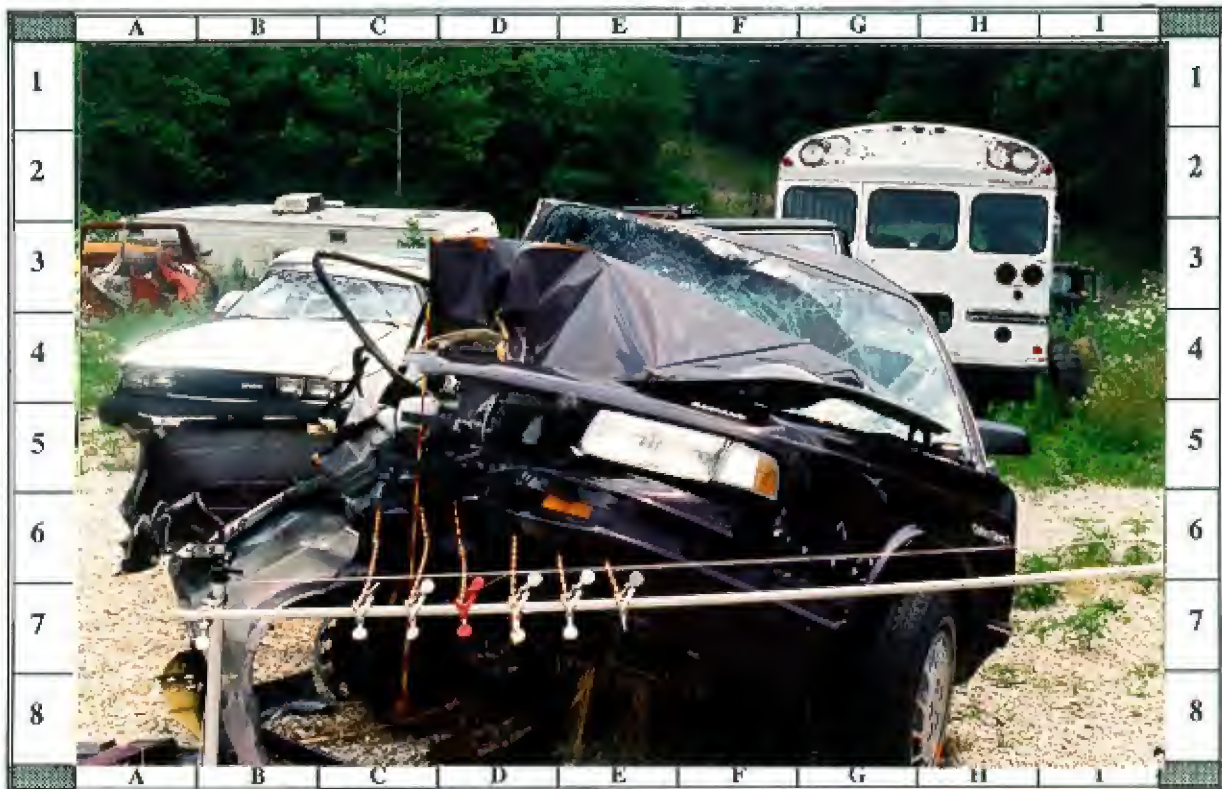
# 33 — 1994 Oldsmobile Cutlass Ciera S's front right corner impact with large (~37 cm) tree; NOTE: contour guage and shifting

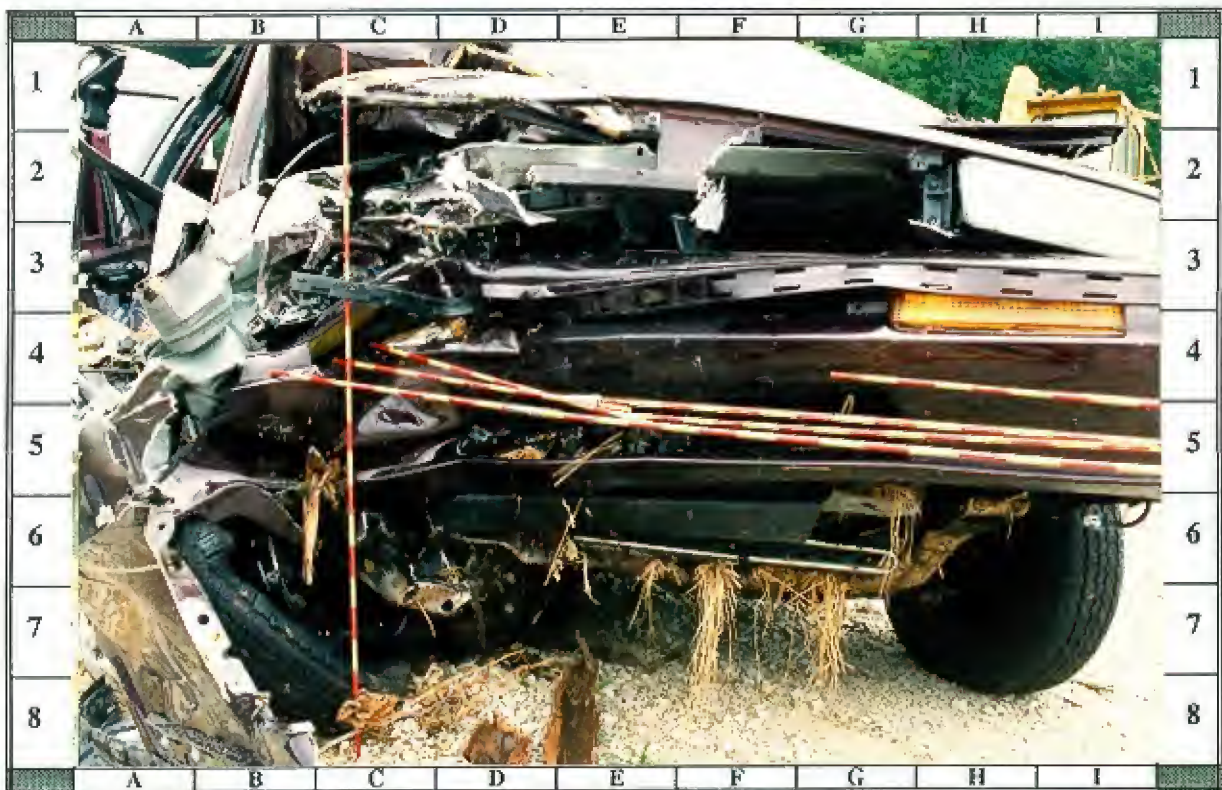
# 34 — Close-up with contour guage of front right impact to 1994 Oldsmobile Cutlass Ciera; NOTE: undercarriage grass from extraction

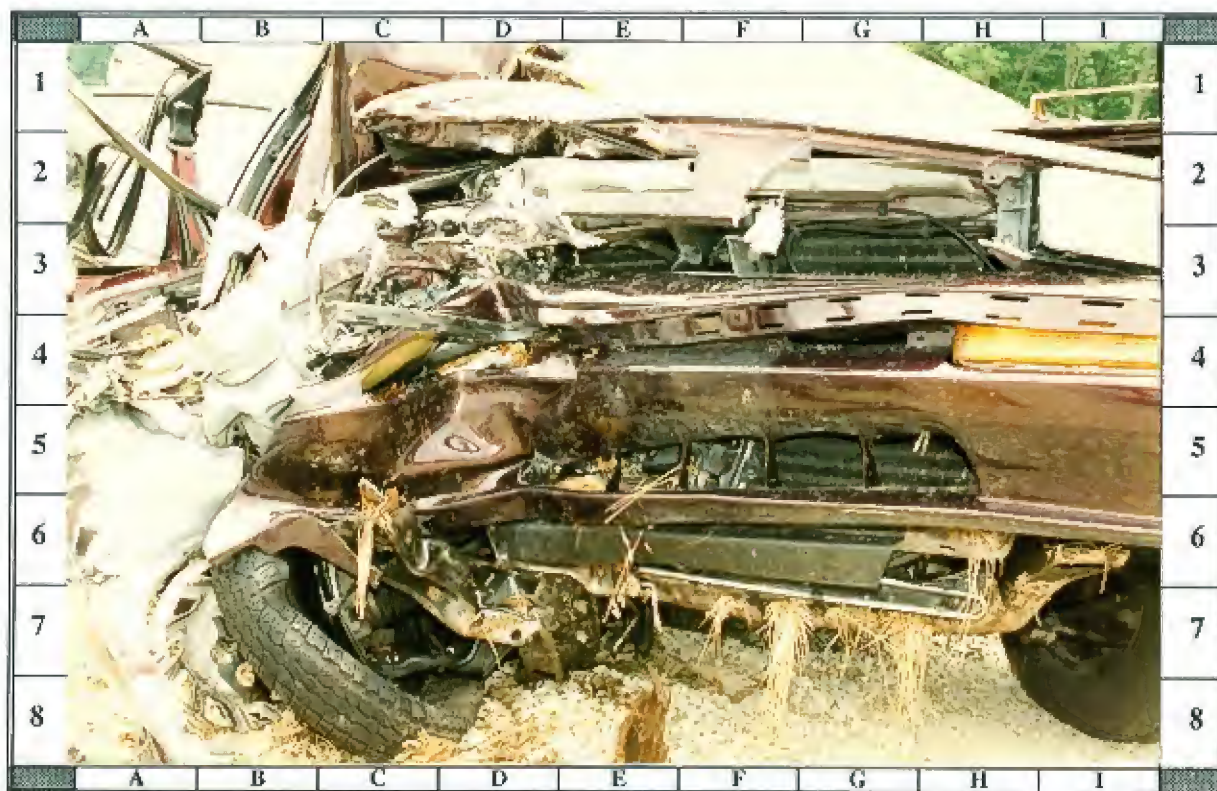
# 35 -- Close-up without contour guage of front right crush to '94 Oldsmobile Cutlass Ciera; NOTE: undercarriage grass from extraction

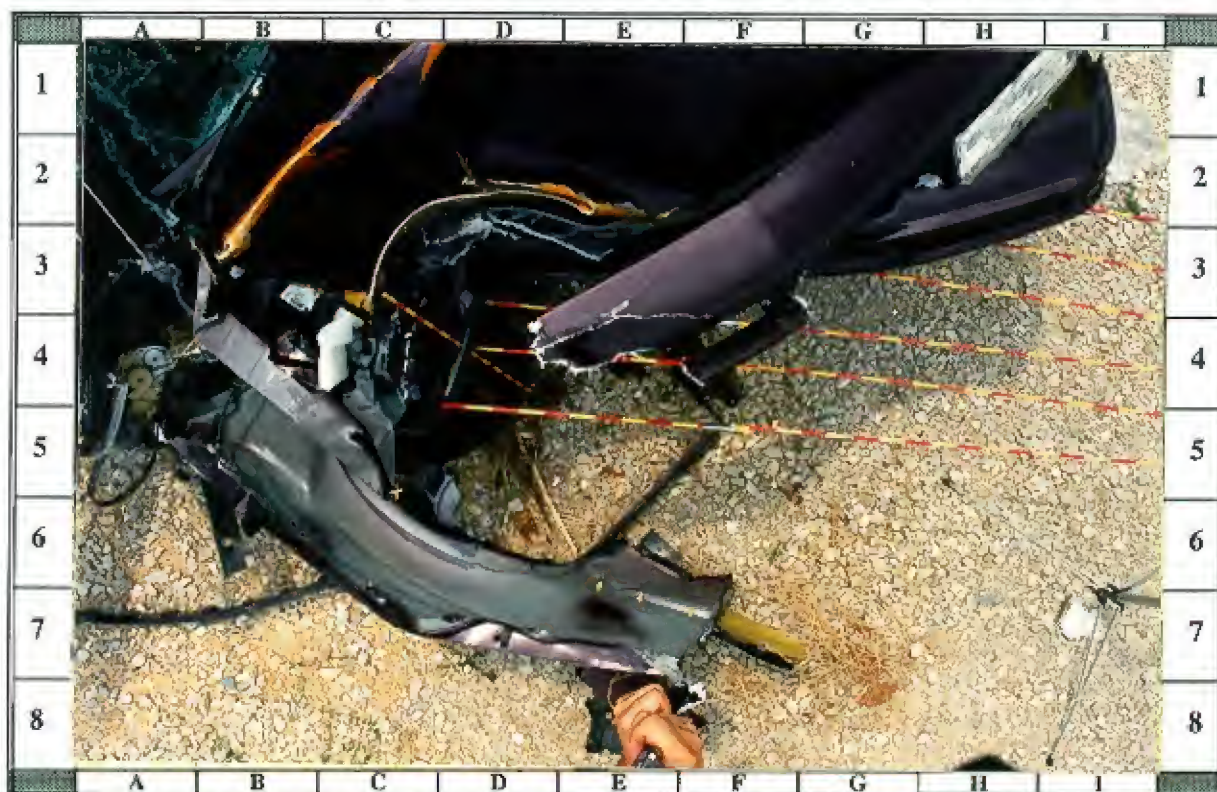
# 36 -- Right front overhead view of front right crush to '94 Oldsmobile Cutlass Ciera S from large tree (~37 cm) impact

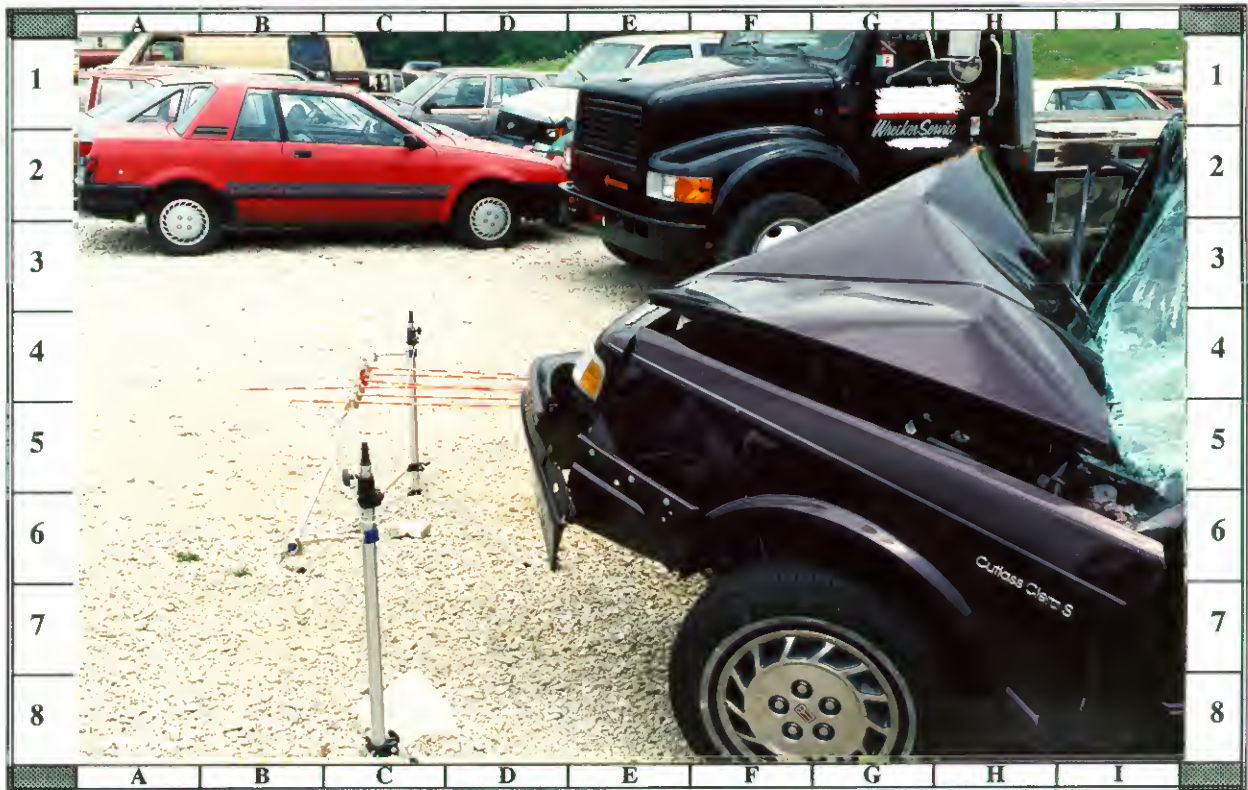
# 37 -- 1994 Oldsmobile Cutlass Ciera S's front crush with contour guage viewed across reference line from left

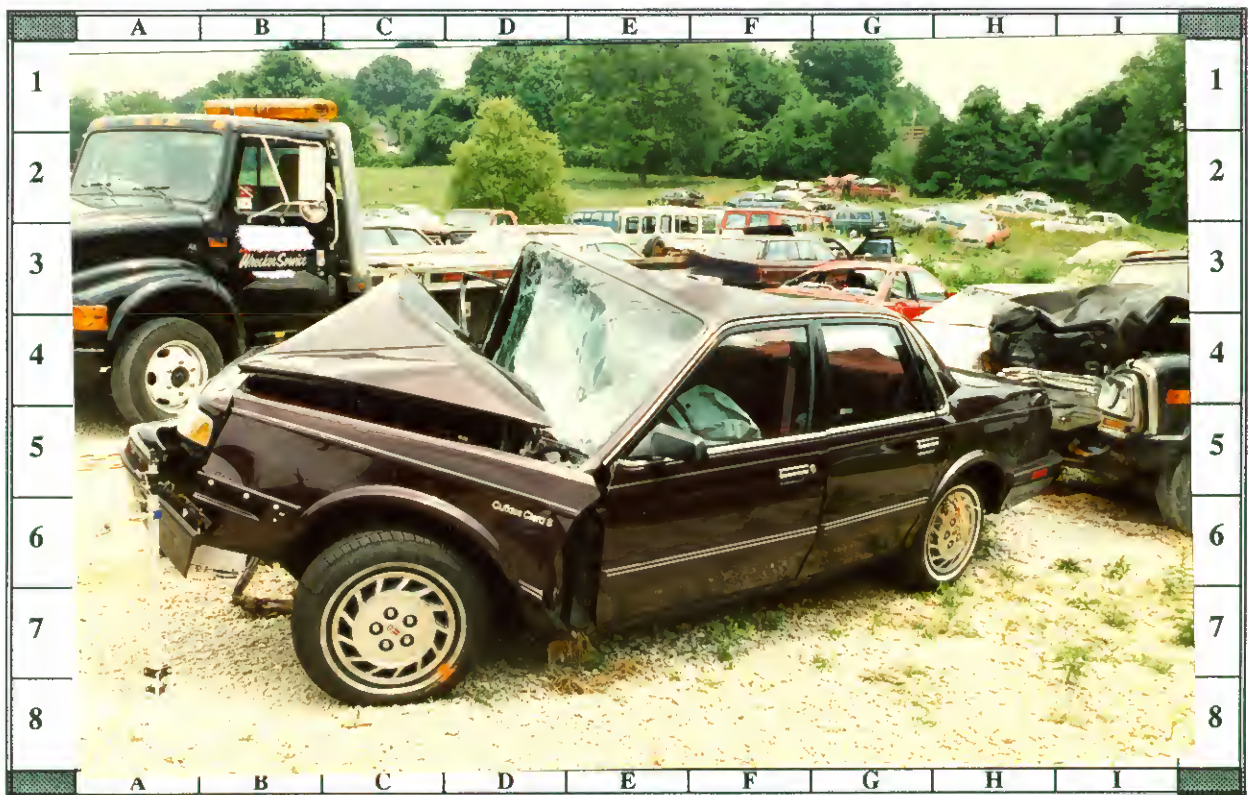
# 38 -- 1994 Oldsmobile Cutlass Ciera S viewed from left showing frontal rightward shift and induced damage to right A-pillar

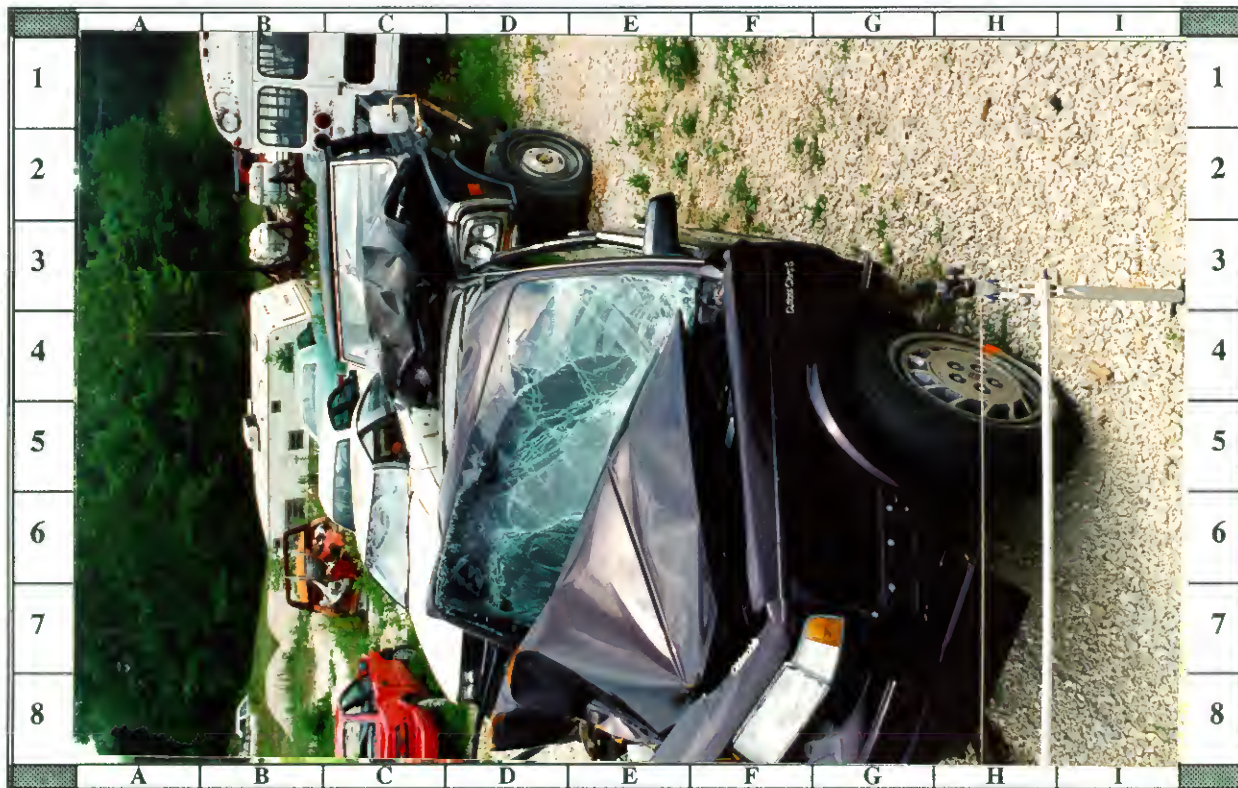
# 39 -- 1994 Oldsmobile Cutlass Ciera S viewed from front along left side showing frontal rightward shift

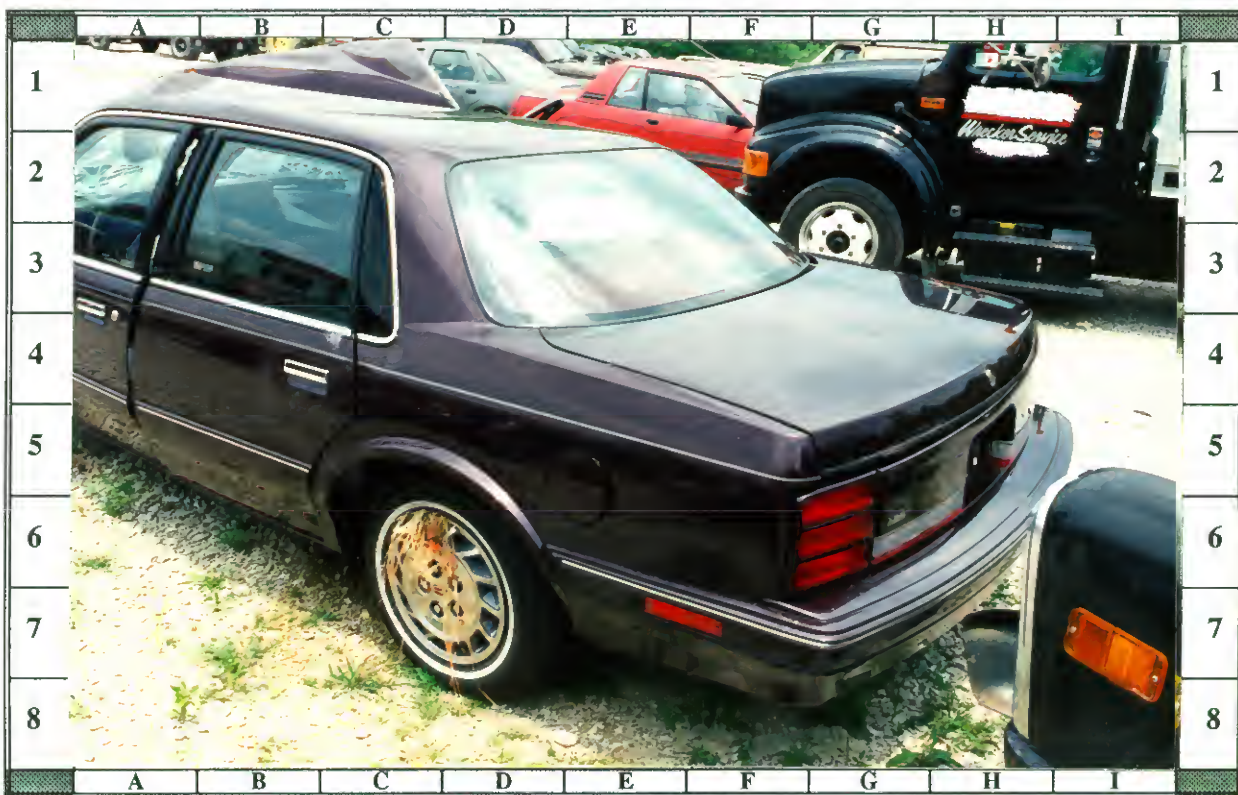
# 40 -- 1994 Oldsmobile Cutlass Ciera S viewed from back left; NOTE: grass and orange paint (see cells C6--D6) on left rear wheel

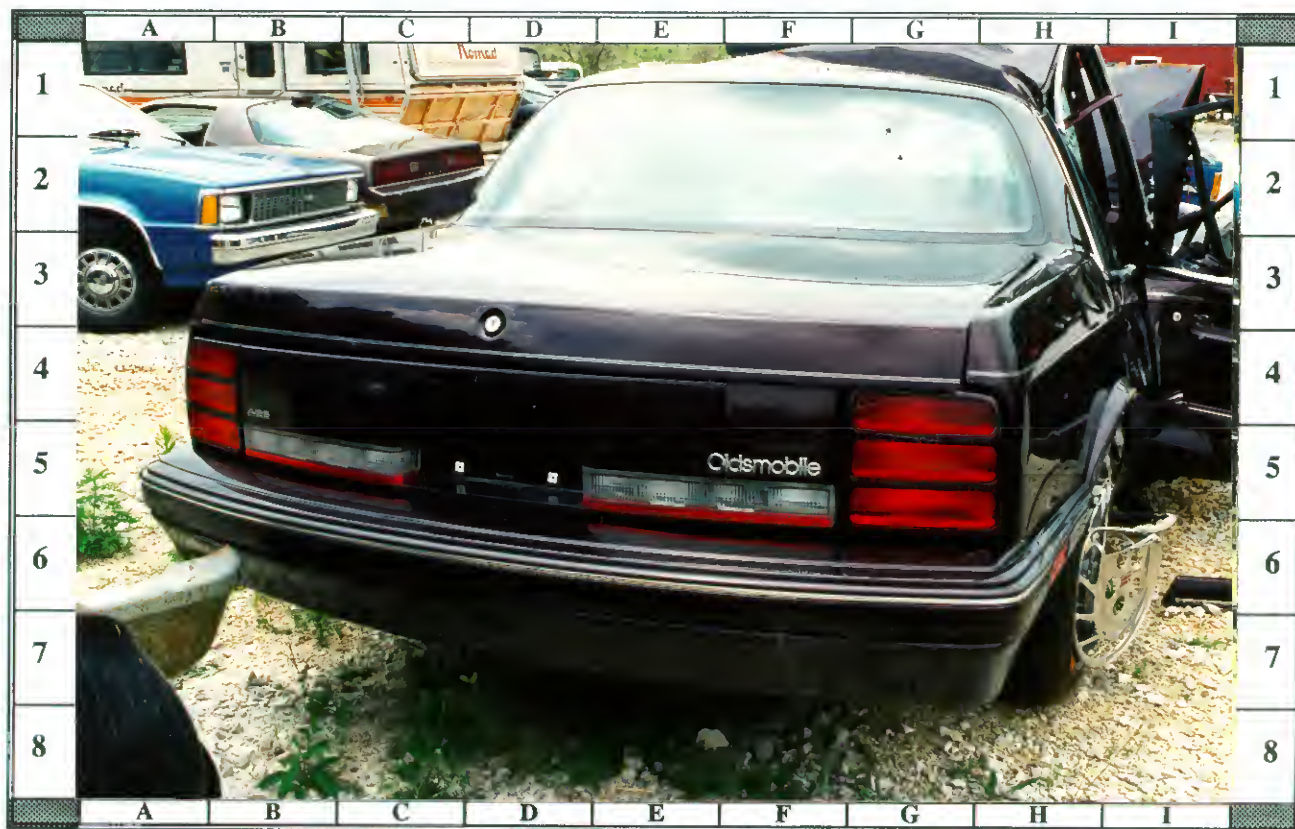
# 41 -- 1994 Oldsmobile Cutlass Ciera S viewed from back; NOTE: induced damage to right A-pillar and roof and impact to RR wheel cover

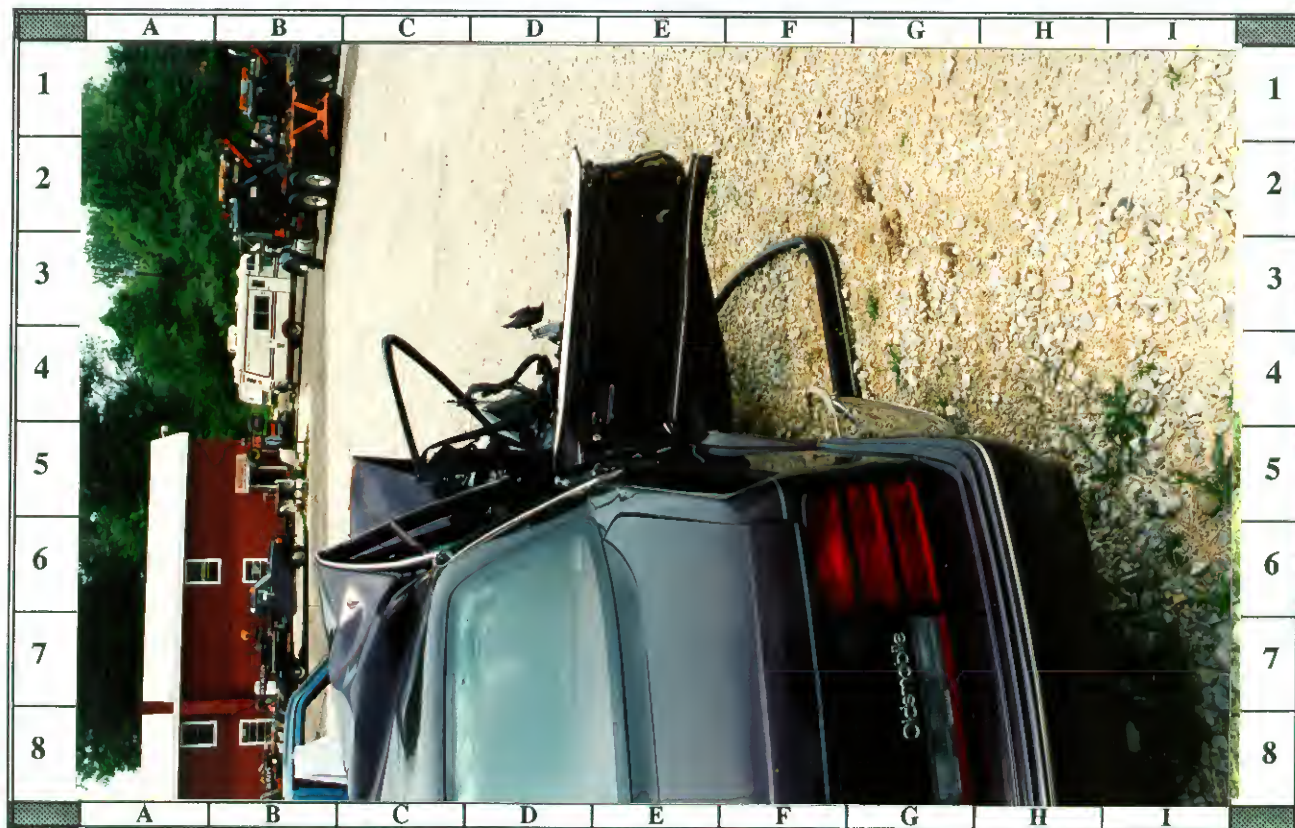
# 42 -- 1994 Oldsmobile Cutlass Ciera viewed from back along right side showing induced damage to right A-pillar, roof, and RF door

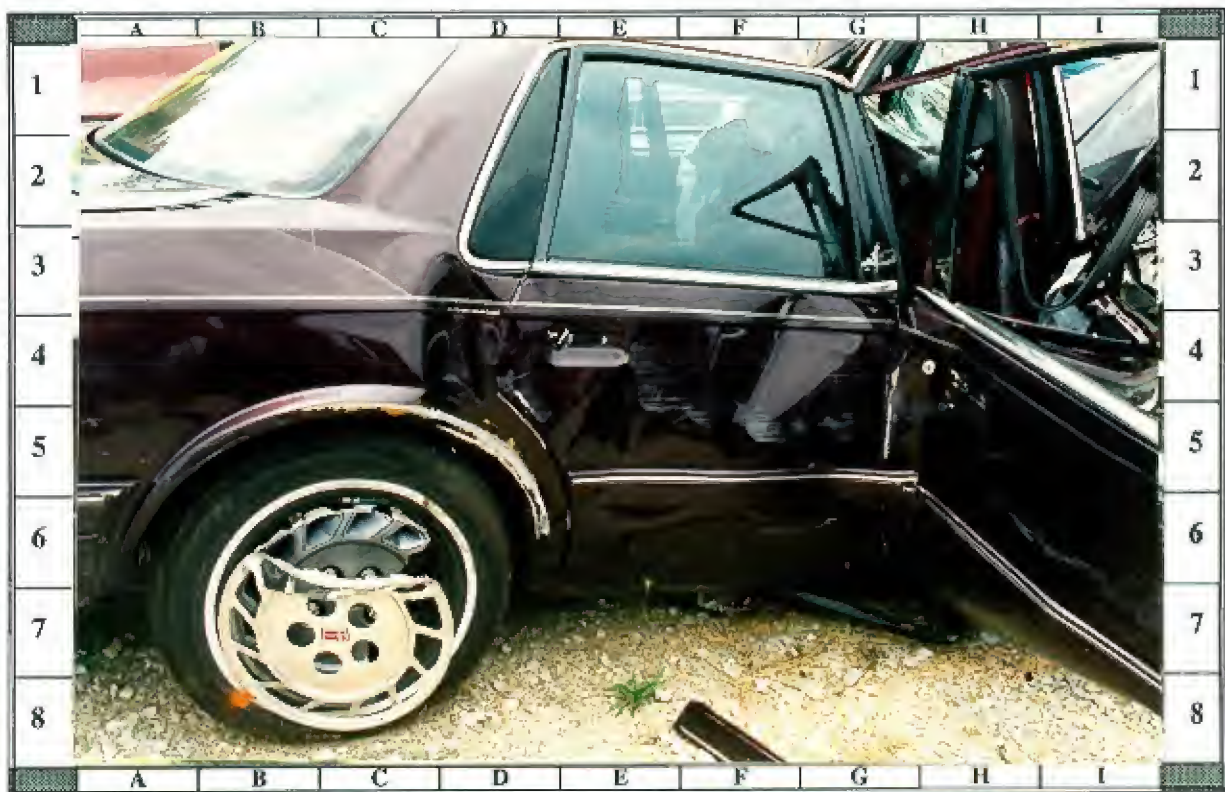
# 43 – Close-up of '94 Oldsmobile viewed from right showing right door panels & RR wheel rim & cover damage from sign post impact (3rd)

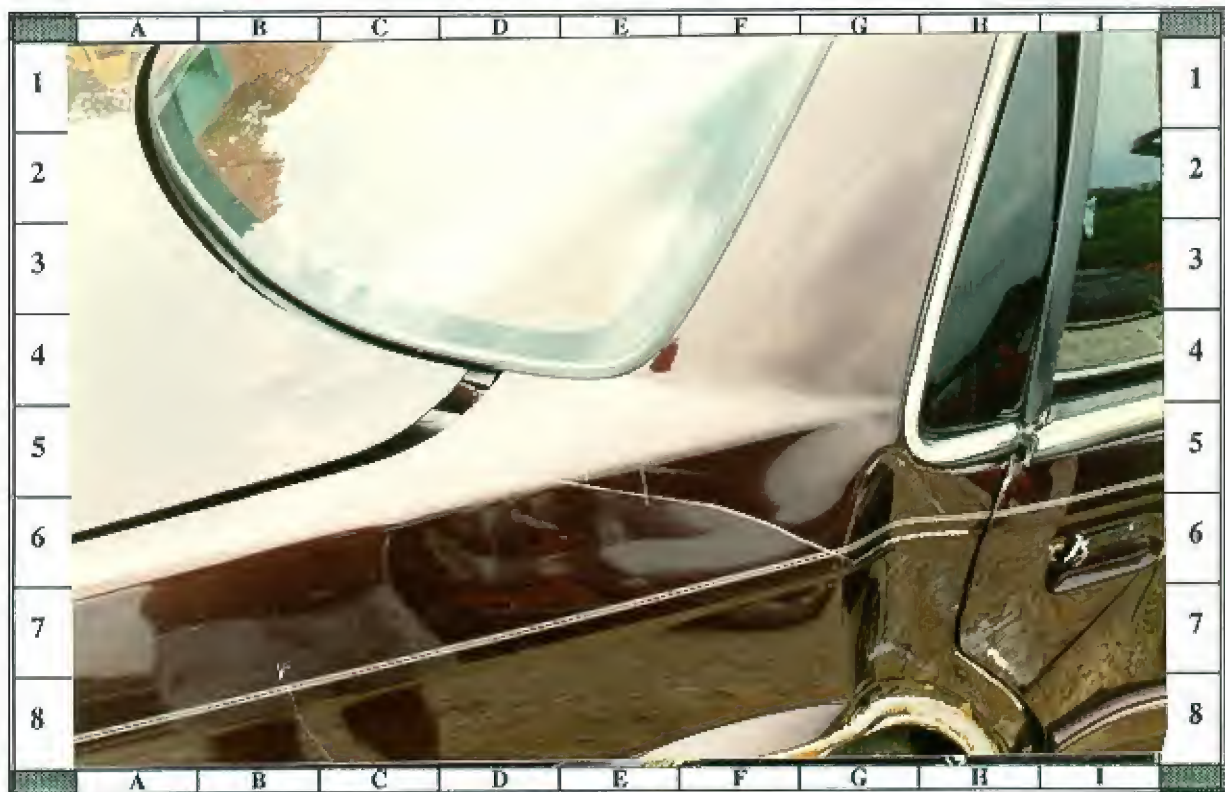
# 44 – Closer-up of deep scratch to 1994 Oldsmobile Cutlass Ciera S's right quarter panel from impact (3rd) with subwarning sign
